WASH 1192(Par.)

OPERATIONAL

ACCIDENTS

and RADIATION EXPOSURE EXPERIENCE

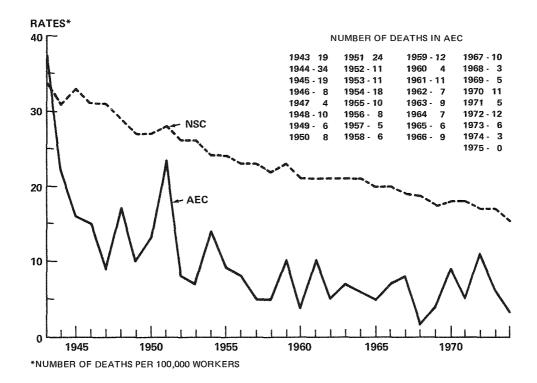
Chart I
DEATH RATES AEC — NSC 1943 TO 1974

Fatalities from all causes totaled 321 during the 32-year period (see Charts I and II). Of this number, 184 occurred in construction, 121 in AEC operations (production, research and services), and 16 in Government functions. A list of fatalities occurring in AEC operational activities appear in Appendix A.

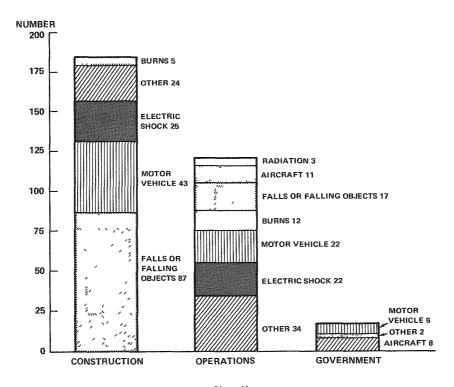
Chart II
TYPES OF FATALITIES IN AEC PROGRAMS
1943 TO 1975

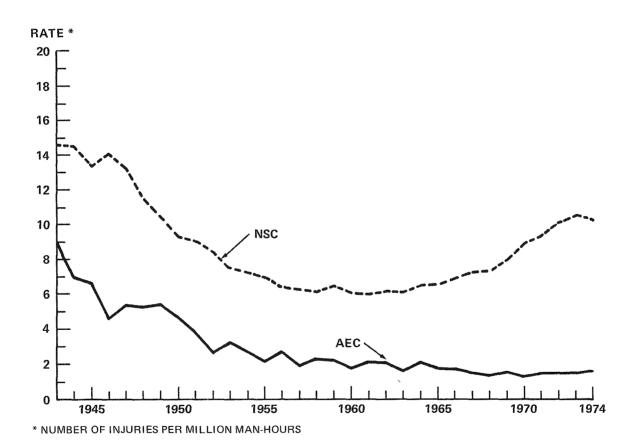
Chart IV

INJURY FREQUENCY RATES AEC - NSC 1943 TO 1974

In 1945, and prior thereto, the pressures of war, such as heavy construction work, urgency, and shortages, all combined to produce relatively high accident frequency rates in AEC operations, although they were always below NSC rates. By 1950, the rate for work in operation had dropped to about 3.0 injuries per million man-hours. From then on, operation frequency rates were low by comparison with other industries. In 1947 through 1949, a renewed heavy construction program produced a construction injury rate of about 10.0. This

held the overall frequency rates of the AEC up in those years. A vigorous program concentrating on control of accidents in construction brought the frequency down again, and since 1958, the total frequency for all activities has been 2.2 or less. The proportion of construction work thereafter was small enough to be ineffective, in the overall, even though the construction rate was up in 1959. It is notable that the trend of AEC's injury frequency (see Chart IV) in all its operations throughout the years is roughly parallel to the national average, but from a fourth to a third of the national rate.

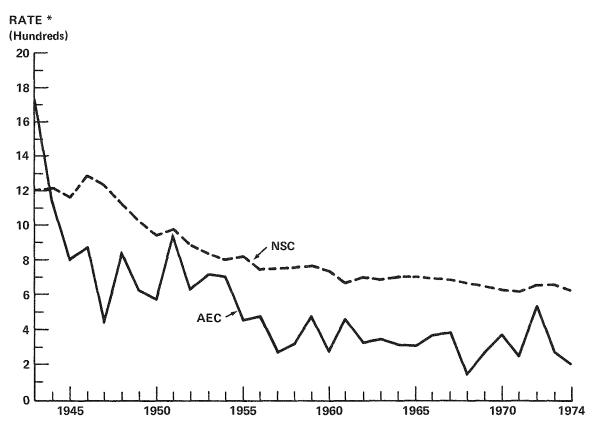
* NUMBER OF DAYS CHARGED PER MILLION MAN-HOURS

Chart V
INJURY SEVERITY RATES AEC — NSC 1943 TO 1974

In 1951, the AEC severity rate and the NSC severity rate were the same. Both have declined over the years; however, that of the AEC shows a greater decrease (see Chart V).

It is to be noted that a severity rate may fluctuate markedly from year to year, depending upon the fatalities and types of disabilities occurring. Whereas the actual calendar days lost are charged for temporary total injuries, charges are based on 6,000 days for a death or permanent disability, with proportionately fewer days being charged for permanent partial disabilities of varying degrees of seriousness. Thus, fatalities and certain types of injuries can result in decided peaks in a severity rate.

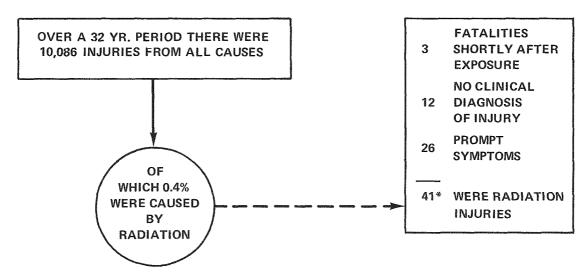
* 3 FATALITIES AT SL-1 (Caused by explosion) NOT INCLUDED

Chart VII RADIATION INJURIES 1943 TO 1975 AEC Operations

During the 32 years of operation of the AEC and its predecessor, radiation resulted in a very small percentage (0.4) of the total lost-time injuries from all causes as indicated in Chart VII. These specific radiation exposures were classified as lost-time injuries as defined in the American National Standards Institute methods for reporting work injuries, ANSI Z16.1–1967 (Rev. of Z16.1–1954) and AEC directives.

Of the 41 workers involved in lost-time radiation accidents, 3 died, 26 showed clinical manifestations attributable to radiation, and 12 were without evidence of radiation effects. Of the second group, 3 received permanent partial disabilities due to radiation, 3 required removal of a digit because of deposition of plutonium in tissue, and one other required removal of a digit because of direct X-ray damage.

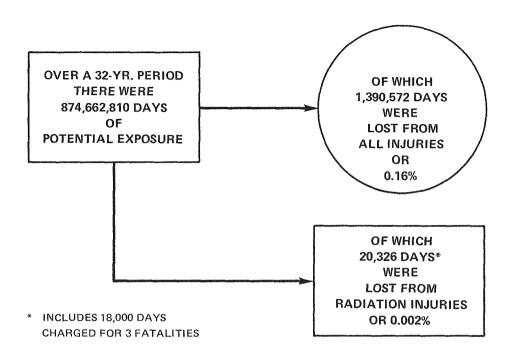
Chart IX
TIME LOST FROM RADIATION INJURIES 1943 TO 1975
AEC Operations

Additional information on these injuries concerning date and location of accident and nature and extent of injury are found on Chart VIII. Chart IX provides a comparison of total time lost from injuries due to radiation and to other causes. It is evident from the chart that radiation exposure was responsible for only a small part of the time lost due to injuries.

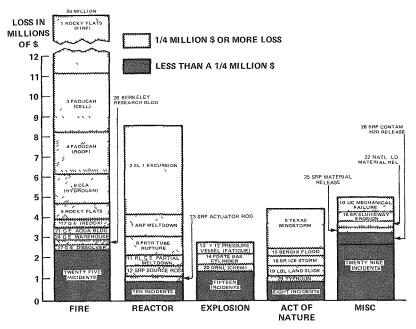
Chart X

AEC INCIDENTS CAUSING OVER \$50,000 PROPERTY LOSS OR DAMAGE
1943 - 1975

NUMBERS CORRESPOND WITH CHART XIV

As indicated on Chart X, fire accounted for three quarters of the total AEC loss experience. The May 11, 1969, fire at Rocky Flats (see page 15) more than tripled the AEC's cumulative fire loss ratio up to that time. Since 1969, intensified fire protection programs combined to make the 5 years since 1969 the 5 best years in AEC history. Even with the \$45,000,000 Rocky Flats

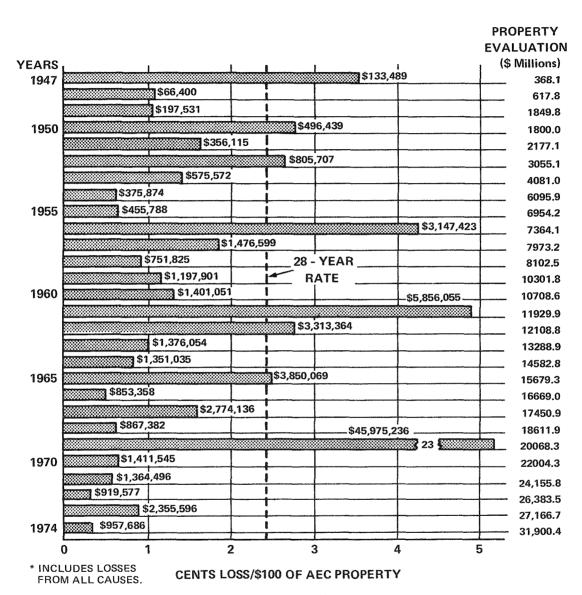
CHART XI
AEC PROPERTY DAMAGE RATIOS*... 1947 - 1974

Chart XI shows a breakdown of the AEC 1947–1974 property damage experience and reflects an average annual loss rate of approximately $2.45 \ensuremath{\phi}/\$100$ of AEC-owned property. The 28-year record for all losses (regardless of cause and including decontamination costs) is about

equal to the private insurance industry record for fire losses alone in the best class of insured properties. The wide deviations in the AEC annual loss experience shown on Chart XI are the result of a few high-loss incidents.

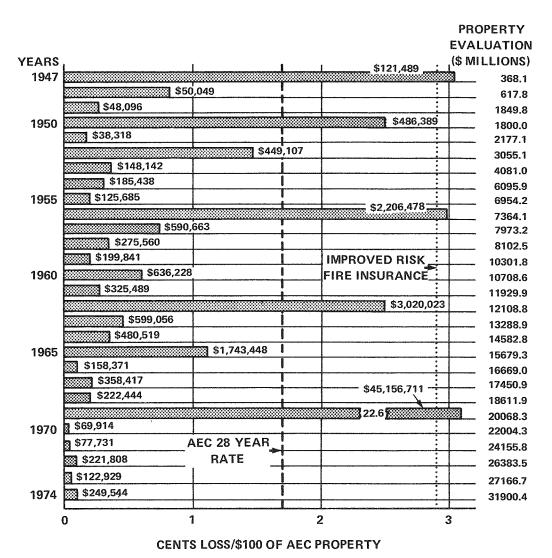
Chart XII
AEC FIRE LOSS RATIOS 1947 – 1974

restoration included, the cumulative AEC loss ratio of 1.7 is well below the average for the best protected class of insured properties. In fact, if AEC loss ratios were equal to those of the better class of insured properties, the AEC would have suffered an additional \$45 million in fire losses over its history.

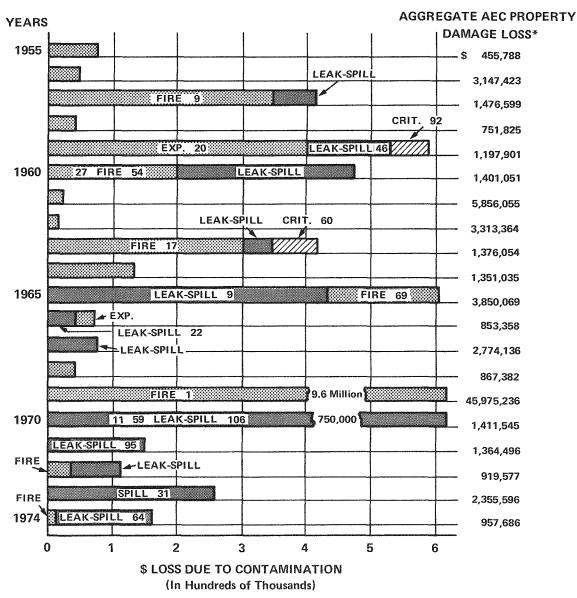
*INCLUDES LOSSES FROM ALL CAUSES

Chart XIII
CAUSES OF CONTAMINATION DAMAGE TO AEC PROPERTY
1955-1974

Chart XIII presents a breakdown by years of AEC property damage from contamination. As noted in the chart, AEC experienced its largest loss due to contamination in 1969 when a fire occurred in a plutonium processing facility at Rocky Flats, Colorado, on May 11. Personnel exposures were within normal ad-

ministrative limits and no appreciable radioactivity was released to the environment. The cost of the incident was \$45,000,000, of which approximately \$9,600,000 was based on the expense for cleanup of radioactive contamination in the facility. Since 1955 the cost of contamination cleanup constituted about 17% of the total losses from all causes.
