First Double-Shell Tank Leaks at Hanford Nuclear Site

“This Changes Everything,”New Urgency for Building More Tanks

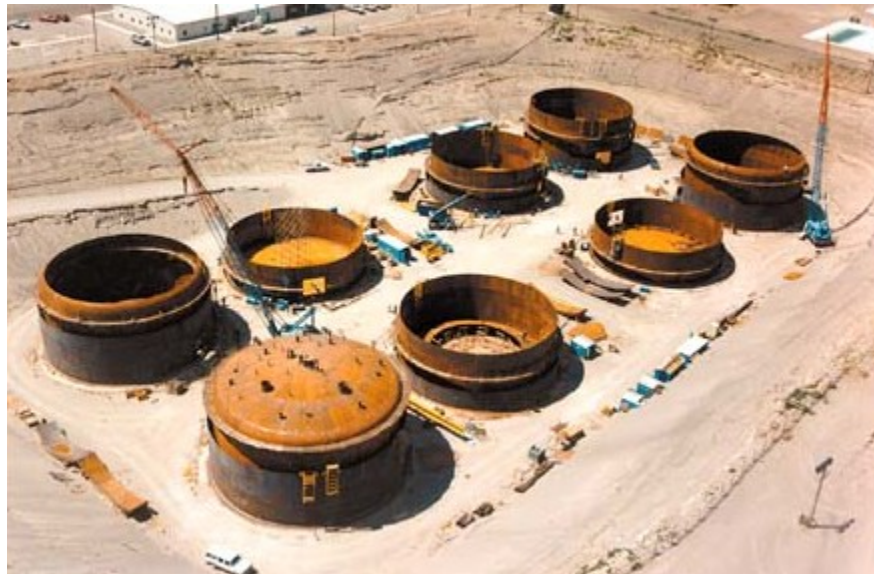
Hanford Tanks Under Construction (Department of Energy photo)

The AY-102 tank is one of 177 underground nuclear waste tanks containing an estimated 56 million gallons of high-level nuclear waste. 67 Hanford tanks have leaked over one million gallons to the soil, but until recently, all of them were the older-style, single-shell tanks. The AY-102 tank is a *double-shell* waste tank, and was previously considered to be stable and non-leaking. Double-shelled tanks have two steel walls, with a “tank within a tank” design that adds to the safety margin.
